SHEAR STRENGTH OF EARTH BAG WALL WITH WEAK COHESIVE FILL

Patricia Stouter, August 2011

ABSTRACT

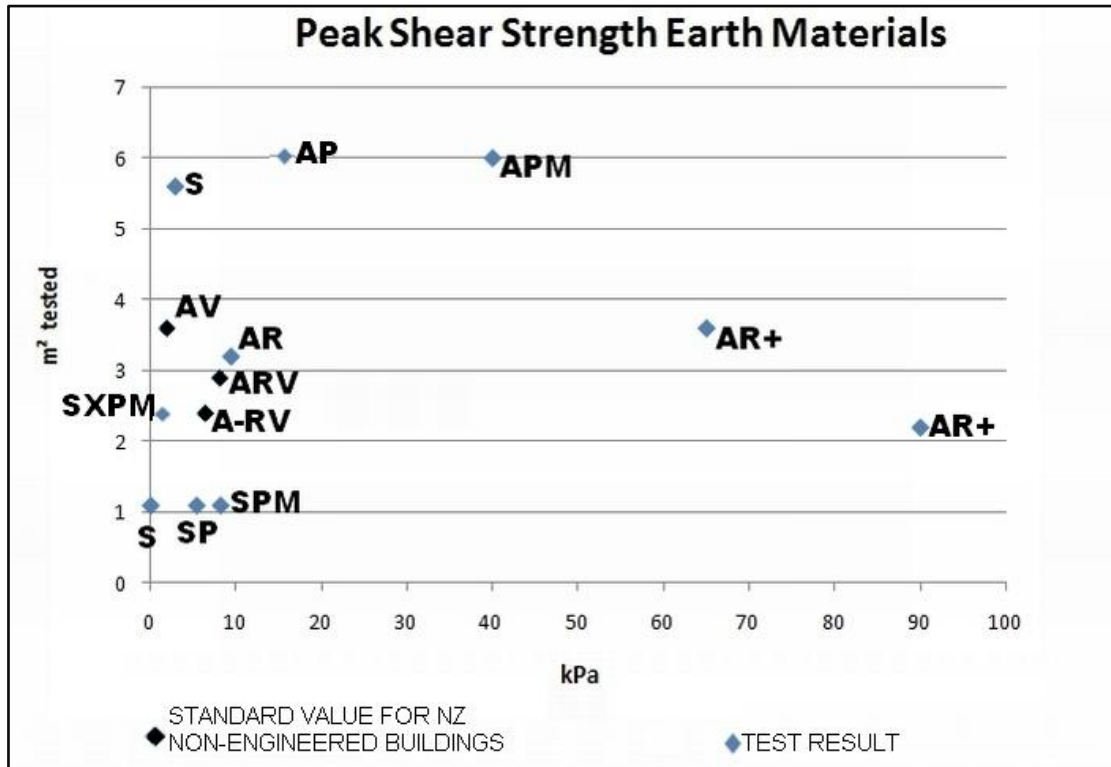
Most tests were completed with dynamic cyclic horizontal pressure on tops of wall portions. Only the CUP test reflects shake table performance of an entire building (for this one record m^2 tested is an approximate figure for the wall length that does not reflect total area of building walls).

LEGEND

S = EARTH BAG WALL WITH NON-COHESIVE SAND FILL

Note: All designers use factors of safety to insure that there is a margin of error to prevent damage to buildings. The NZS committee recommends a design factor at 70% of the failure value for reinforced walls. Test failure values and design strengths were adjusted by this proportion to provide fair comparisons.

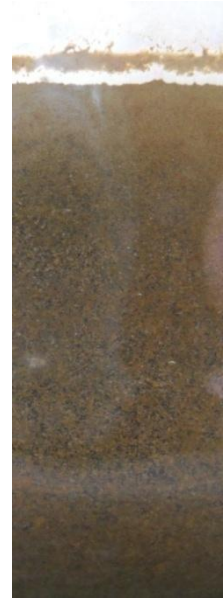
Right: View of settled soil sample

The soil used was mostly a material called silt by a local gravel yard, with about 20% by volume of a moderate strength clay added. The clay contained both fine and very coarse sand with some very fine gravel. The traditional earthbag builder sediment test¹⁵ revealed a profile of more than half silt, and less than 10% clay. A soil sample has been retained for more accurate analysis.

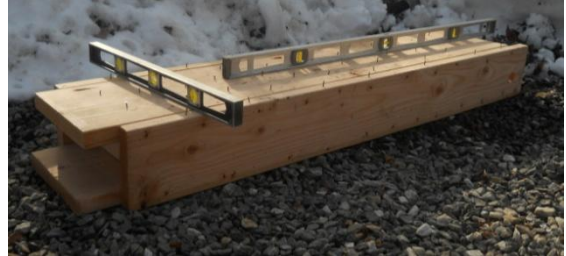
Right: wooden base

A 5'-6"/ 1.7 m long wooden base was constructed of pressure treated Douglas fir assembled with galvanized deck screws. 2x8/ 50x200 lumbers formed the sides and 2x12s/ 50x300 formed the top and bottom plates. 4 pieces of blocking were included inside to support the wall weight. Galvanized metal nailer plates were added above the axle holes and at the ends of the boards for reinforcement.

Right below: Metal plates at axle location

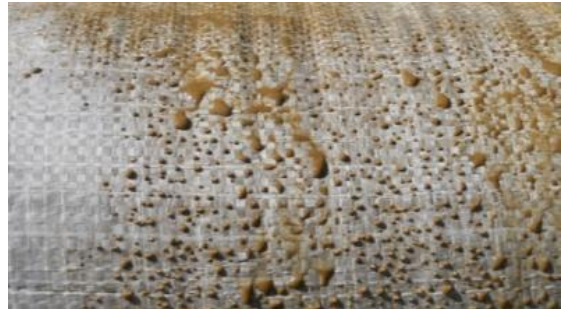
Right: Weeper bag

Because of the high silt content, soil moisture content was hard to regulate perfectly. No drier batches of mix were used, but many batches were damp enough to cause 'weeper' bags. These bags ooze moisture as tamped. It is noted in *Earthbag Building*¹⁷ that these types of bags with clay fill cure stronger than drier bags. With a silty fill these bags are too bouncy to compact under tamping unless dried for a day first. The damper silty bags were not obviously stronger.

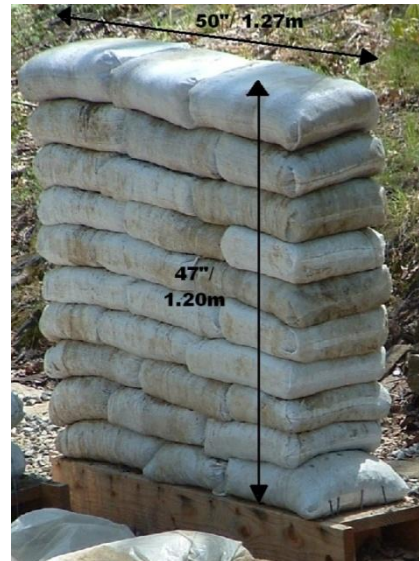
Right above: Before and after tamping
Right: Finished test wall

During tamping each bag course reduced in size from 7" to 5" / 18 to 12.5 cm and became firm. Bag courses also keyed into the course below and settled around the wire barbs during tamping.

10 courses total of bags were placed, with sides and ends plumb. .

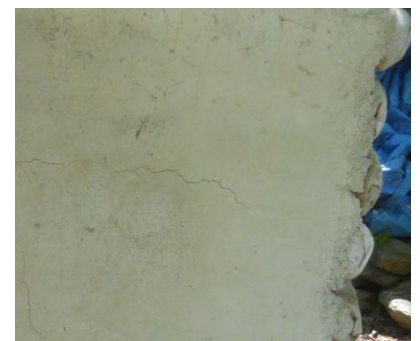
Right above: Lime and earthen plaster side view
Right: Lime plaster condition when cured

This plaster consisted of moderate strength clay with a small amount of added sand and manure. Several days later a single coat of lime plaster was added to one side and an earthen finish coat on the other. The lime plaster was 1 part lime putty to 3 parts sand with added chopped straw. Thickness of finish layers varied from 0.50- 1 inch/ 1.5- 2.5 cm. Bags were left exposed at the ends of the wall.

These finish surfaces were kept covered with a tarp and sprayed lightly with water twice a day during curing. After two months of curing the finish plaster coats were well dried. The lime plaster dried with 4 minor non-structural cracks less than 1/8 inch/ 3 mm

wide. The longest crack was 10"/ 26 cm long. The earthen plaster had more cracks and wider, some up to a quarter inch/ 6 mm across. All the earthen plaster was well anchored to the wall, and fibers were visible spanning the cracks and uniting the plaster.

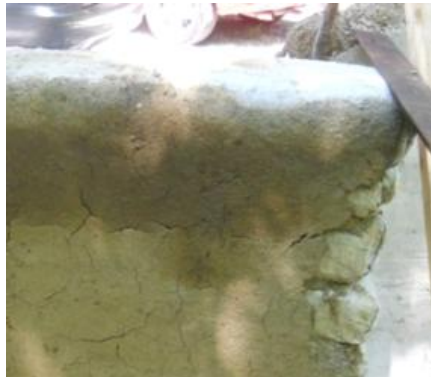
Below: Earthen plaster condition at time of testing

Testing occurred 2 months after plastering. At the time of testing the lime plaster and most of the finish earthen plaster was dry. Because of leaking through the tarp covering the wall portion, the earthen finish plaster at the upper corner where the diagonal pressure was applied was damp.

Right top: Earthen plaster crack close-up

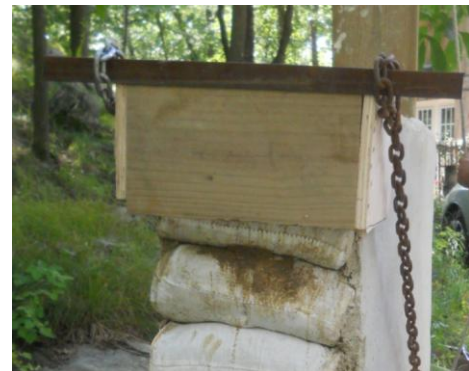
Right top: Overall view of testing

An upper corner bracket was attached by chains to a lever arm on the opposite side base. The far end of the lever arm was attached to a rope that led through a single pulley to a support for weights.

Right: Corner bracket

The plywood corner bracket was capped by a piece of angle iron. Chains looped over and ran down to turnbuckles.

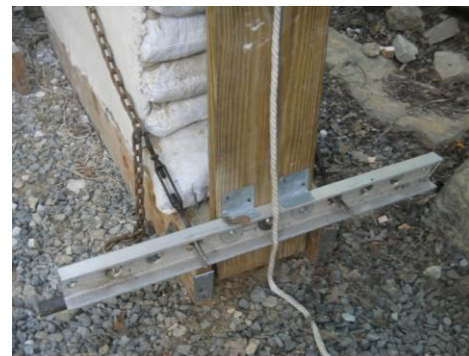
Right bottom: Chain attachment to lever

The lever arm was a single 2x10/ 50x250 of pressure treated Southern Yellow pine. Metal brackets were screwed to the wood to seat the lever arm in place on a pivot point formed by an axle of metal pipe. The turnbuckles were attached to a strong piece of aluminum channel bolted to the other side of the lever. The turnbuckles ran through eye-bolts held in place with large washers.

The chain was attached to the lever arm 5"/ 13 cm above the center of the axle on which it rotated. A rope was tied to the other end of the lever arm exactly 113"/ 2.87 m from the axle. This produced a mechanical advantage of 22.6 to 1.

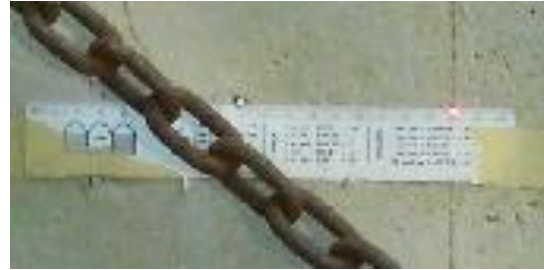
Right top: The laser dot at the beginning of testing

A vertical line was marked on the finished plaster surface in pen from the top of the wall to the bottom. At the level of the second course from the top a thin plastic metric ruler was taped and nailed to the plaster with brads. A contractor's laser level located 4'/ 1.2 m distant was aimed at the ruler.

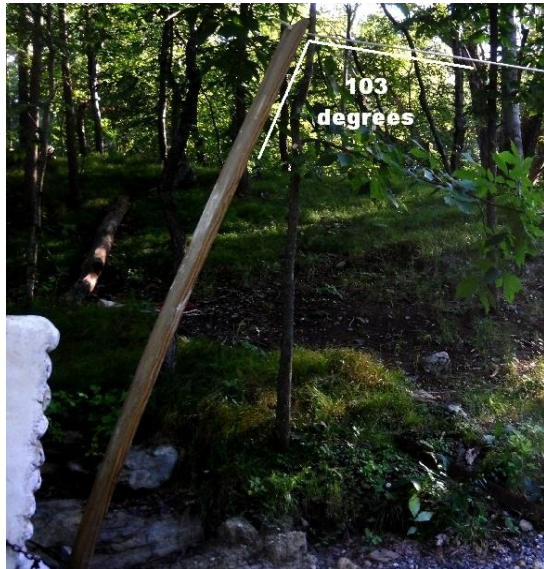
Right: Lever arm and rope angle

A strong nylon was used for the rope from the lever arm to a pulley suspended by ropes in line with the wall. Force was applied to the lever arm by placing gym weights on a shelf of wood and metal strapping.

Three times the wall withstood the force applied by 100 lbs./ 46 kg with only 0.3 inch/ 8 mm displacement and little plaster cracking. The lever arm formed an angle between 90 and 103 degrees with the rope during tests.

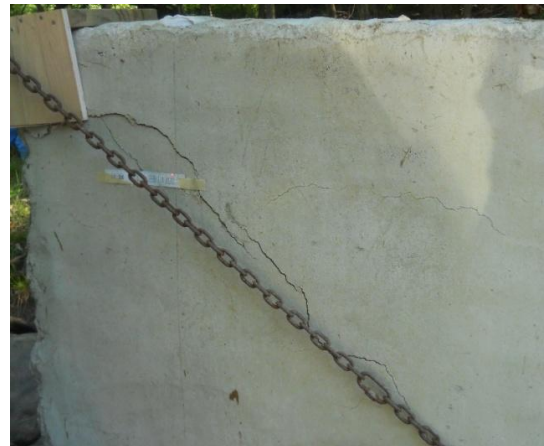
Right: Cracking after 2nd application of 100 lbs.

After the first two applications of 100 lbs./ 46 kg weight (2260 lbs.-force or 10 kN) the wall flexed back to 0.1 or 0.16 inches/ 3 or 4 mm displacement.

During the course of testing the very thin cracks first noted in the lime plaster spread. By the third application of 100 lb./ 46 kg weights cracks had nearly joined and stretched from the upper corner bracket down to within about 24 inches/ 60 cm of the base of the wall near the chain.

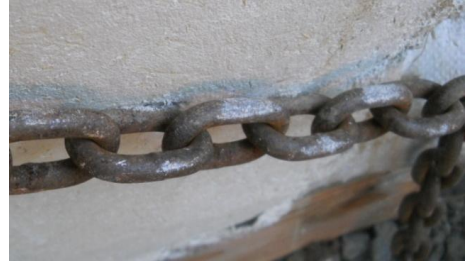
Right: Friction between chain links and plaster

The chain rubbed on the plaster for several inches near the bottom corner of the wall. No cracks appeared in this region.

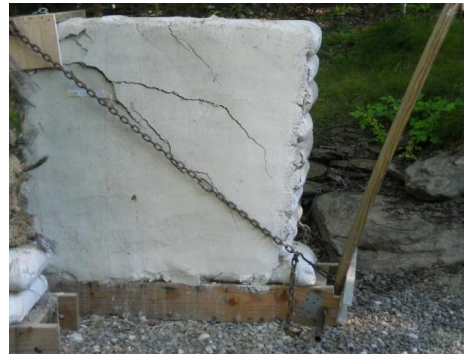
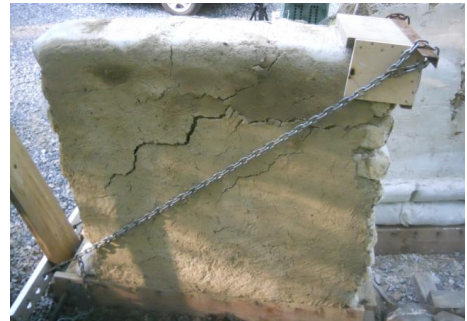
At this force a second major crack developed in the lime plaster above the level of the chain. On the earthen plaster side the most severe cracking was above the chains and obviously stair-stepped.

Right above: Lime plaster after 3rd try of 100 lbs./ 46 kg

Right: Earthen plaster after 3rd try of 100 lbs./ 46 kg

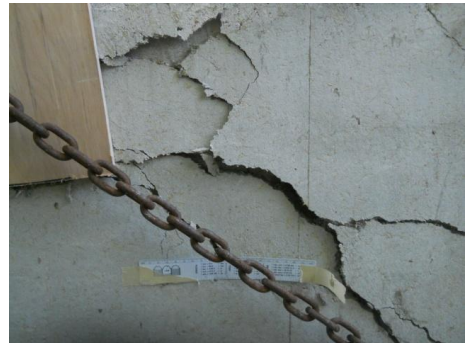
Right bottom: Final condition of lime plaster

After 4 repetitions of more than 120 lbs./ 54 kg weight, the upper plaster was still firmly adhered to the bag wall. Although there were large cracks and some plaster surfaces overlapped, no plaster fell off the wall.

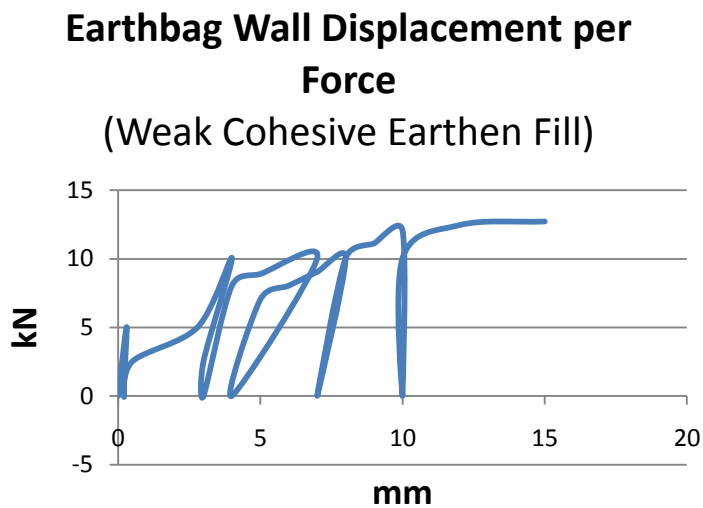
RESULTS DATA			
Weight (lbs.)	Lbs.-force	kN	mm
50	1130	5.02	0
100	2260	10.05	4
50	1130	5.02	4
0	0	0	3
50	1130	5.02	3
75	1808	8.04	4
100	2260	10.05	7
0	0	0	4
50	1130	5.02	4
70	1582	7.04	5
80	1808	8.04	6
90	2034	9.05	7
100	2260	10.05	8
0	0	0	7
120	2712	12.06	10
0	0	0	10
100	2260	10.05	10
120	2712	12.06	10
>120	>2712	>12.06	12+

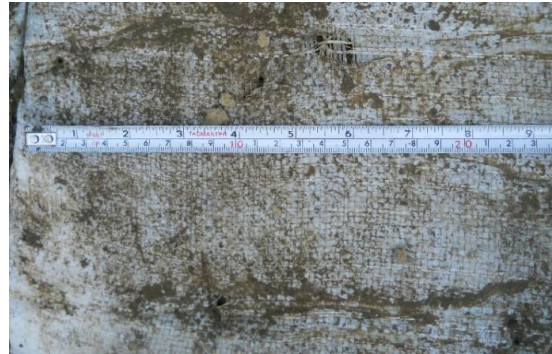
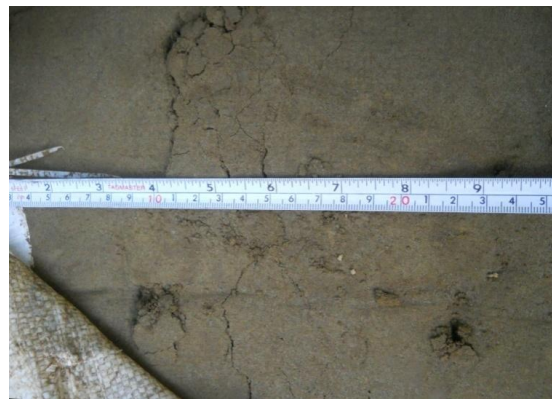
Right: Bag fill loosened at barbed wire points

But when the fabric was removed from two bags in the second course to examine the earthen fill, each wire barb had flaked loose a conical portion of the bag fill material. Some slight cracking in the surface layers was visible between the barb attachment points also. The surface of the earthen unit distant from the barb attachment points was firm and undisturbed.

Shear strength for earthbag depends on the bonds that can transmit the tensile strength of barbed wire to the earth units and their surrounding fabric. Strong clay fills, like those used in adobe, when tamped become strong enough that barbed wire barbs will bend back rather than gouge or flake the bag fill under stress.

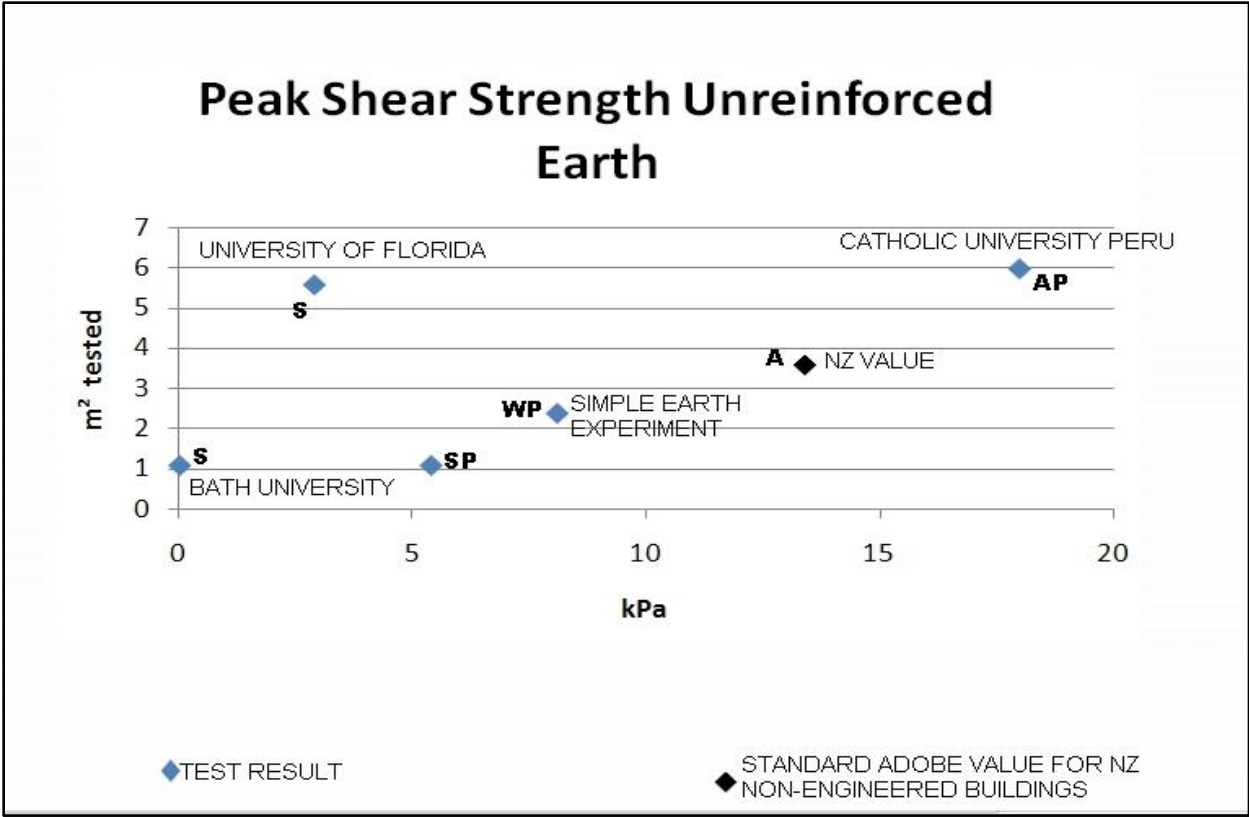
How does earthbag compare to the required and tested strengths of adobe?

LEGEND
S = EARTHBAG WALL WITH NON-COHESIVE SAND FILL **A** = ADOBE WALL
P = PLASTERED
